Project Highlight - North Highland Avenue

PROJECT HIGHLIGHT

*32+ years of wear and tear on a smooth surfaced asphalt built-up roof takes its toll and **the time had finally come for a new roof!** The owner contacted Apollo again. We did a thorough onsite inspection including a moisture scan to determine if any underlying insulation was wet or damaged. A detailed proposal was prepared and a plan of action was generated.*

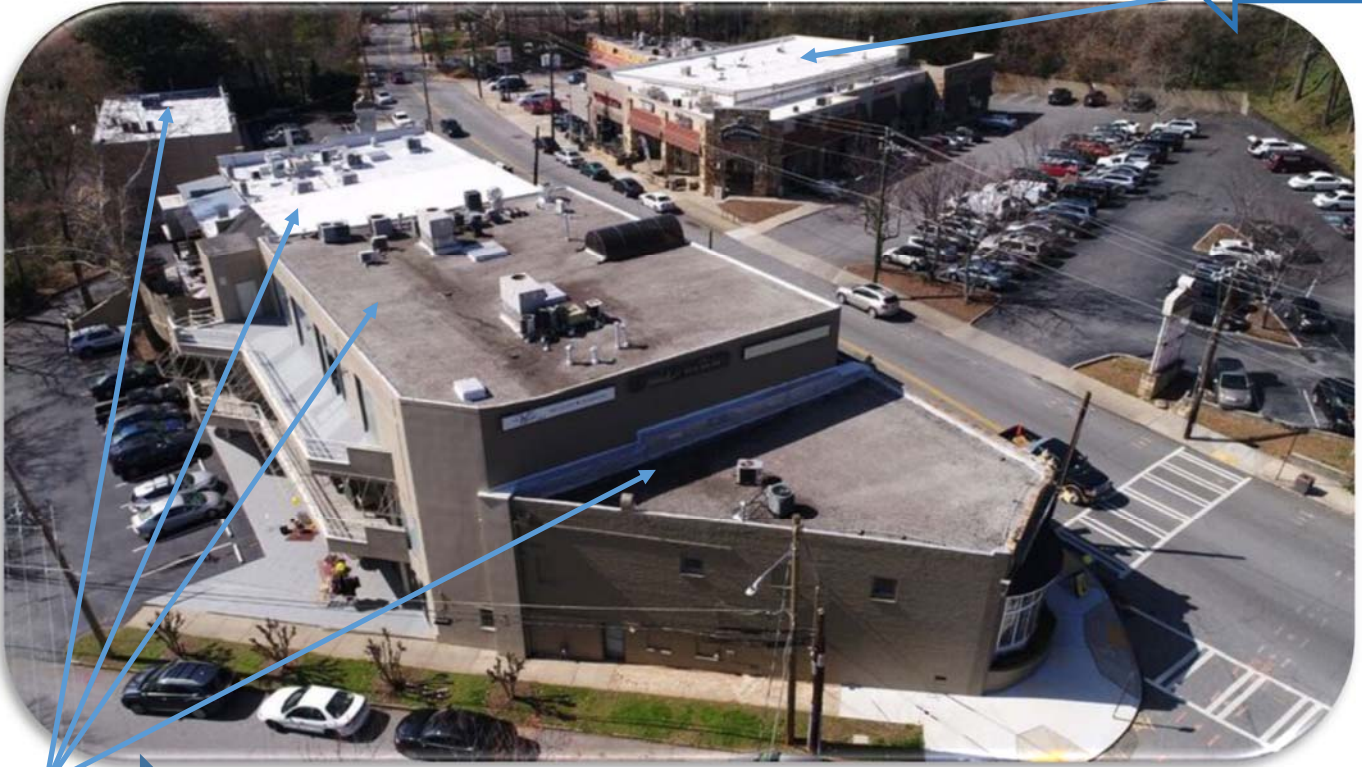
The buildings in the foreground all have Apollo roofs that are 12-22+ years old. By performing routine roof inspections then completing the recommended repairs, we have kept these roofs going for years. They show no sign of needing to be replaced any time soon and had ZERO leaks this past winter and spring. Routine maintenance always increases roof life and decreases crisis roof leaks making both the tenants and the owners happy as expensive replacement is postponed and crisis leaks rarely occur.

The shining white roof in the right background is a new TPO roof system with high R-value insulation that was just installed by Apollo. It was time to replace the roof we put on the building approximately 32± years ago (one of Apollo's first projects!)

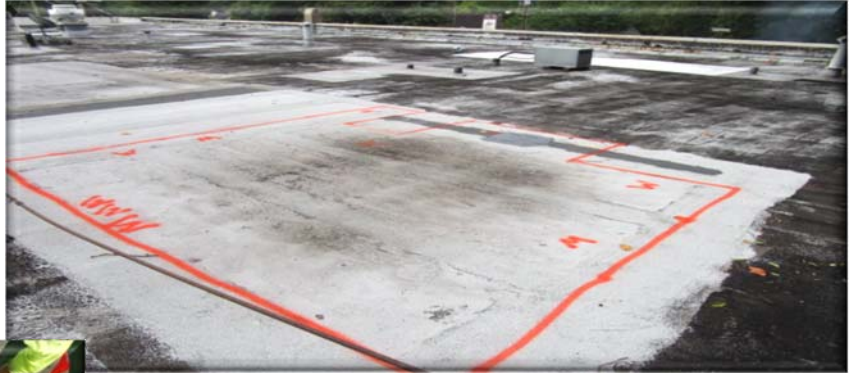
Roof inspection revealed wet insulation.

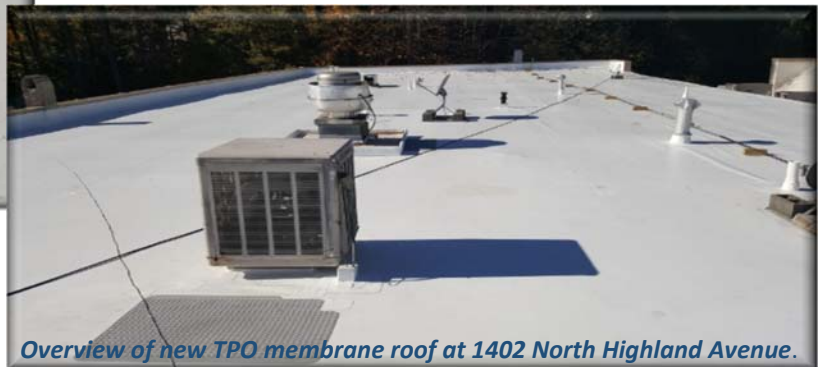
Overview of new TPO membrane roof at 1402 North Highland Avenue.
